Prepared for:

Buyer or Seller
C/o Your Agent
Agent's Company

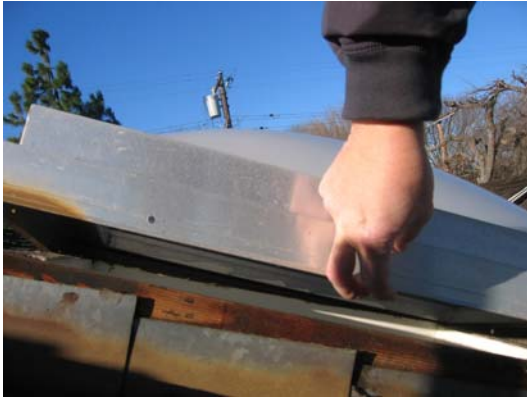
Sample view of a loose non anchored skylight

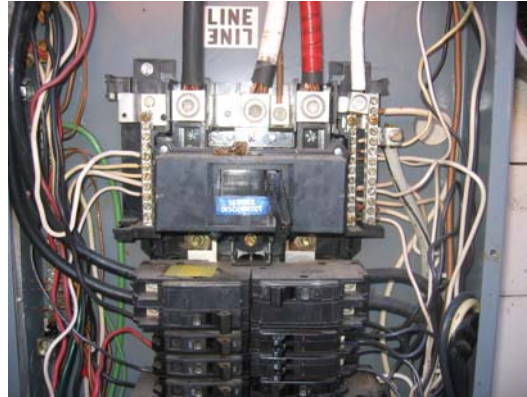
View of the neutral bus bars apparently not bonded to the box in the main panel

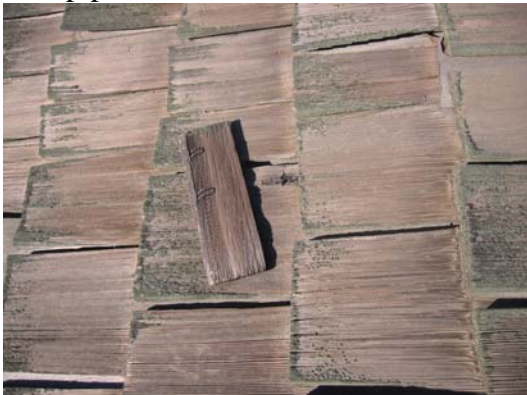
Sample view of damaged roofing materials

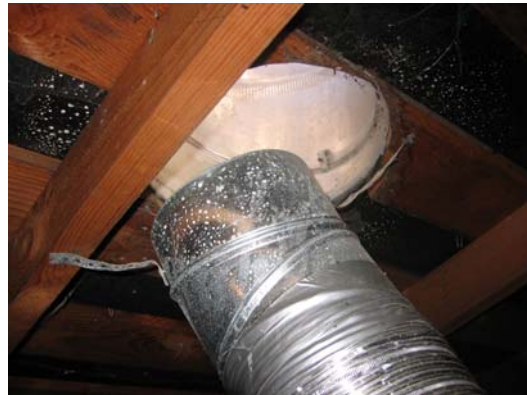
View of the kitchen exhaust duct not extended into the roof jack

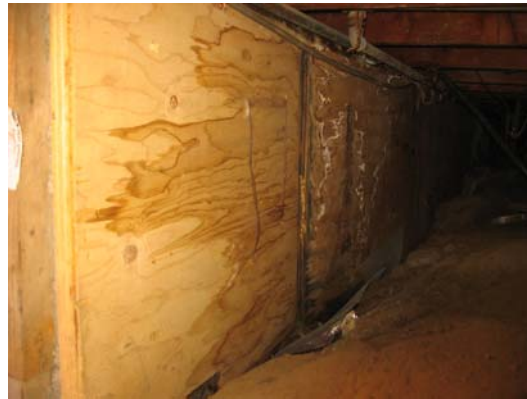
Sample view of the wood form boards still installed at the foundation

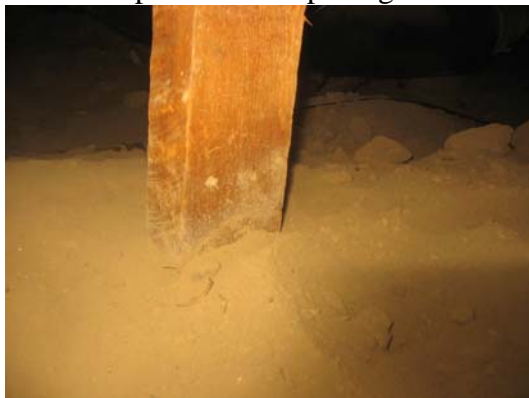
Sample view of wood to earth contact at an added pier post

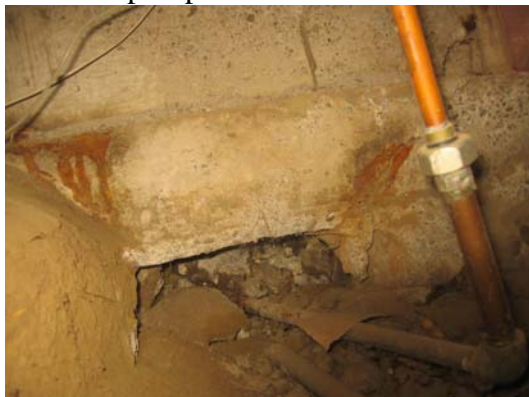
View of the soils subsided under the foundation

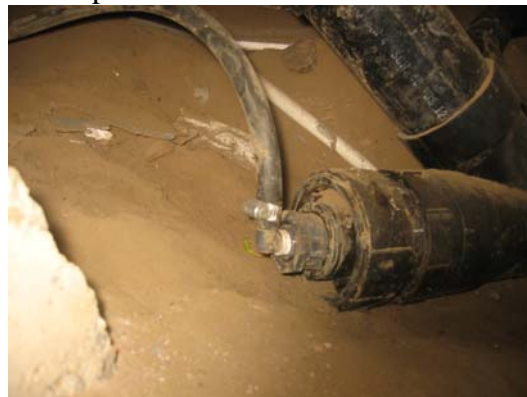
View of the water treatment system attached directly to the sewer line

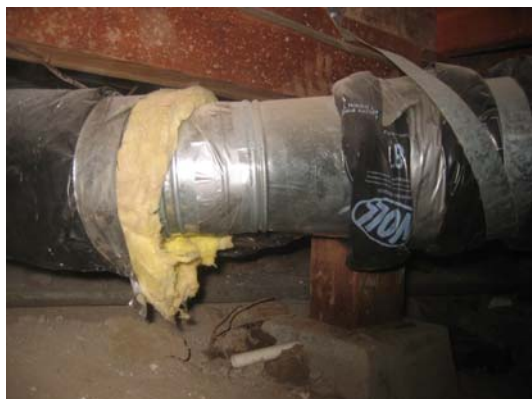
Sample view of ducting partially missing insulation

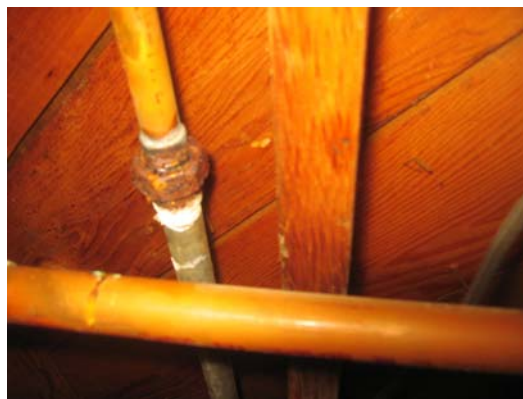
Sample view of corrosion at a fitting in the crawlspace

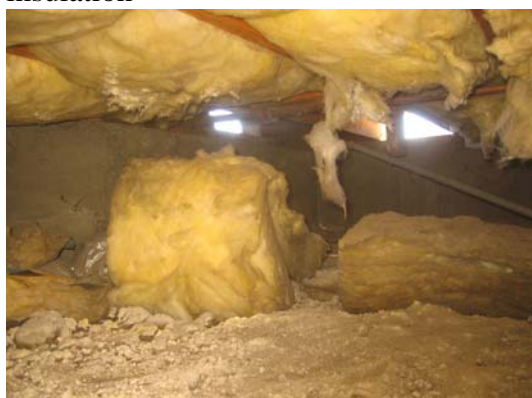
Sample view of fallen floor insulation under the master bedroom
